# Manhole Inspection Summary

Manhole # S07QQ1018MH

Insp Date: **3/14/08 12:27 PM**

**Location** Address: **5200 MAPLE AVE**

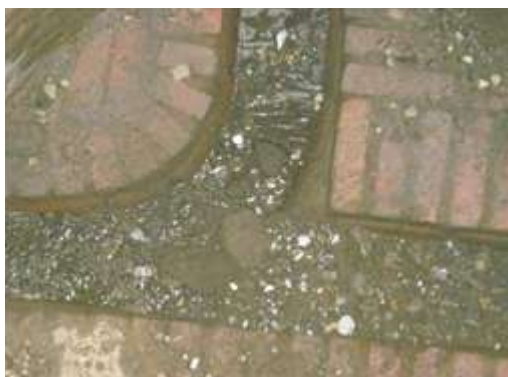
Defect 3

DEBRIS IN CHANNEL

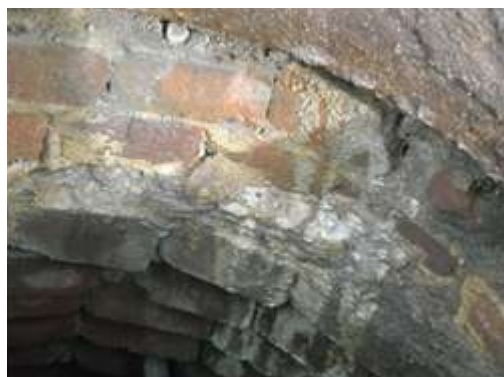
Defect 2

Infiltration: ☐ None ☐ Joint ☐ Cracks ☐ Mortar ☐ Roots ☒ Wall

CORBEL INFILTRATION

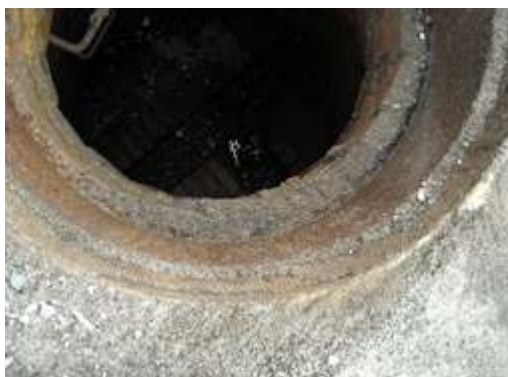
Defect 1

**Frame** Offset: **2** (in.) Condition: ☒ Sound ☐ Cracked ☐ Leaks

FRAME OFFSET

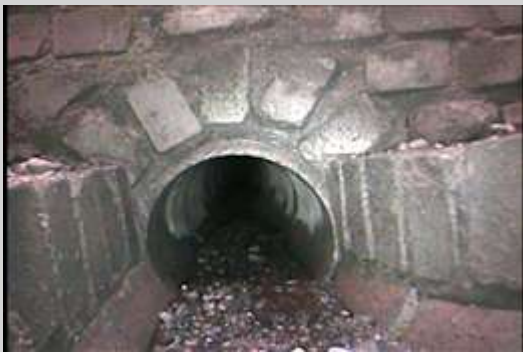
12 O'Clock Outflow

Pipe Height: **7.2** (in.) Rod and Bar (Angled)  
Pipe Material: **Clay** ☐ Pipe Lined  
Invert Depth: **7.66** (ft.) Flow Characteristics: **None**  
Deposits: ☐ None ☐ Mud ☐ Sludge ☒ **Debris** ☐ Grease  
Silt Depth: **1** (in.) Deposits Extent: **Light**  
Infiltration: **None** Pipe Seal Cond: **Sound**

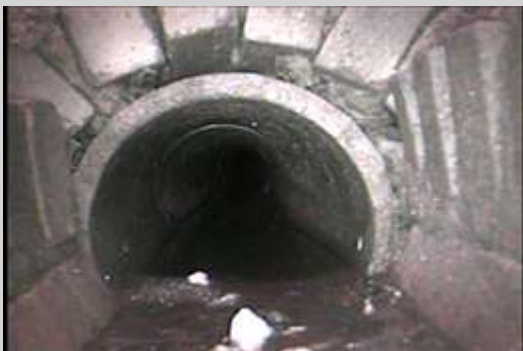
3 O'Clock Inflow

Pipe Height: **7.2** (in.) Rod and Bar (Angled)  
Pipe Material: **Clay** ☐ Pipe Lined  
Invert Depth: **7.75** (ft.) Flow Characteristics: **None**  
Deposits: ☒ None ☐ Mud ☐ Sludge ☐ **Debris** ☐ Grease  
Silt Depth: (in.) Deposits Extent:  
Infiltration: **None** Pipe Seal Cond: **Sound**

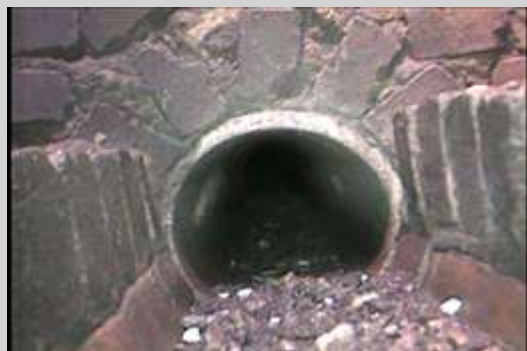
6 O'Clock Inflow

Deposits: ☐ None ☐ Mud ☐ Sludge ☒ **Debris** ☐ Grease

Silt Depth: **2** (in.) Deposits Extent: **Light**
